August 23, 2006

Re: Harmony Heaven- A Planned Unit Development, Cascade Locks, Oregon
GNN Job #: 206-623-1

Subject: Supplemental Geotechnical Engineering Report

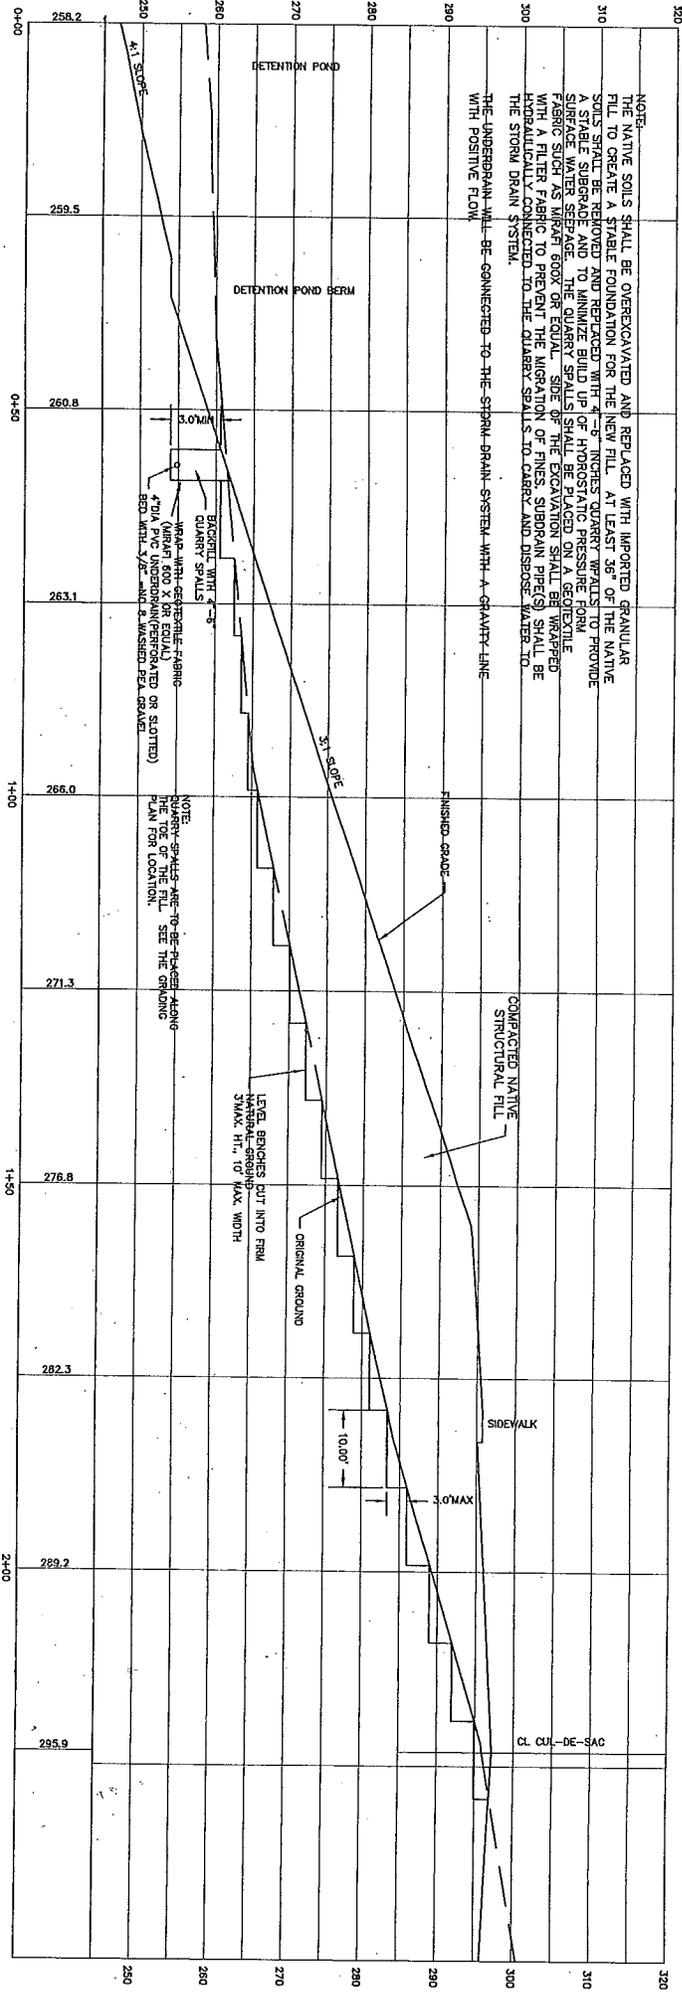
HARMONY HEAVEN SUBDIVISION
 CITY OF CASCADE LOCKS
 SECTION THROUGH FILL AREA

The selected design includes a reconfigured 3:1 slope made of native soil structural fill material. Construction of the slope includes overexcavation and removal of soft and wet to saturated native soils and placement of quarry spalls rock fill at the toe of the slope to allow drainage. Refer to cross section detail "SECTION THROUGH FILL AREA" and "GRADING AND DRAINAGE PLAN" Sheet 2/12 attached to this report depicting details of a 3:1 reconfigured slope.

Prior to new fill placement, the native soft and wet to saturated soils along the toe of the new slope shall be overexcavated and replaced with imported granular fill to create a stable foundation for the new fill. At least 36 inches of the native soils shall be removed and replaced with 4-6 inches quarry spalls to provide a stable subgrade and minimize built-up of hydrostatic pressure from groundwater seepage. The quarry spalls shall be placed on a geotextile separation fabric such as Mirafi 600X or equivalent. Sides of excavation shall be wrapped with a filter fabric to prevent the migration of fines. A subdrain pipe(s) shall be hydraulically connected to the quarry spalls to carry and dispose water by gravity flow to a stormwater drain system. Design of underdrain system shall prevent back flow.

The fill shall be keyed and benched into firm natural soil. From the top of the interior back-cut of the over-excavation, the slope of the re-graded surface shall extend at a minimum 3:1 until it daylight at an elevation of approximately 298. This surface must be benched. As shown on the cross-section detail, the benches should be maximum 10 feet wide with a maximum 3 feet high back-cut. Before fill is placed, the key shall be observed by a representative of GN Northern to

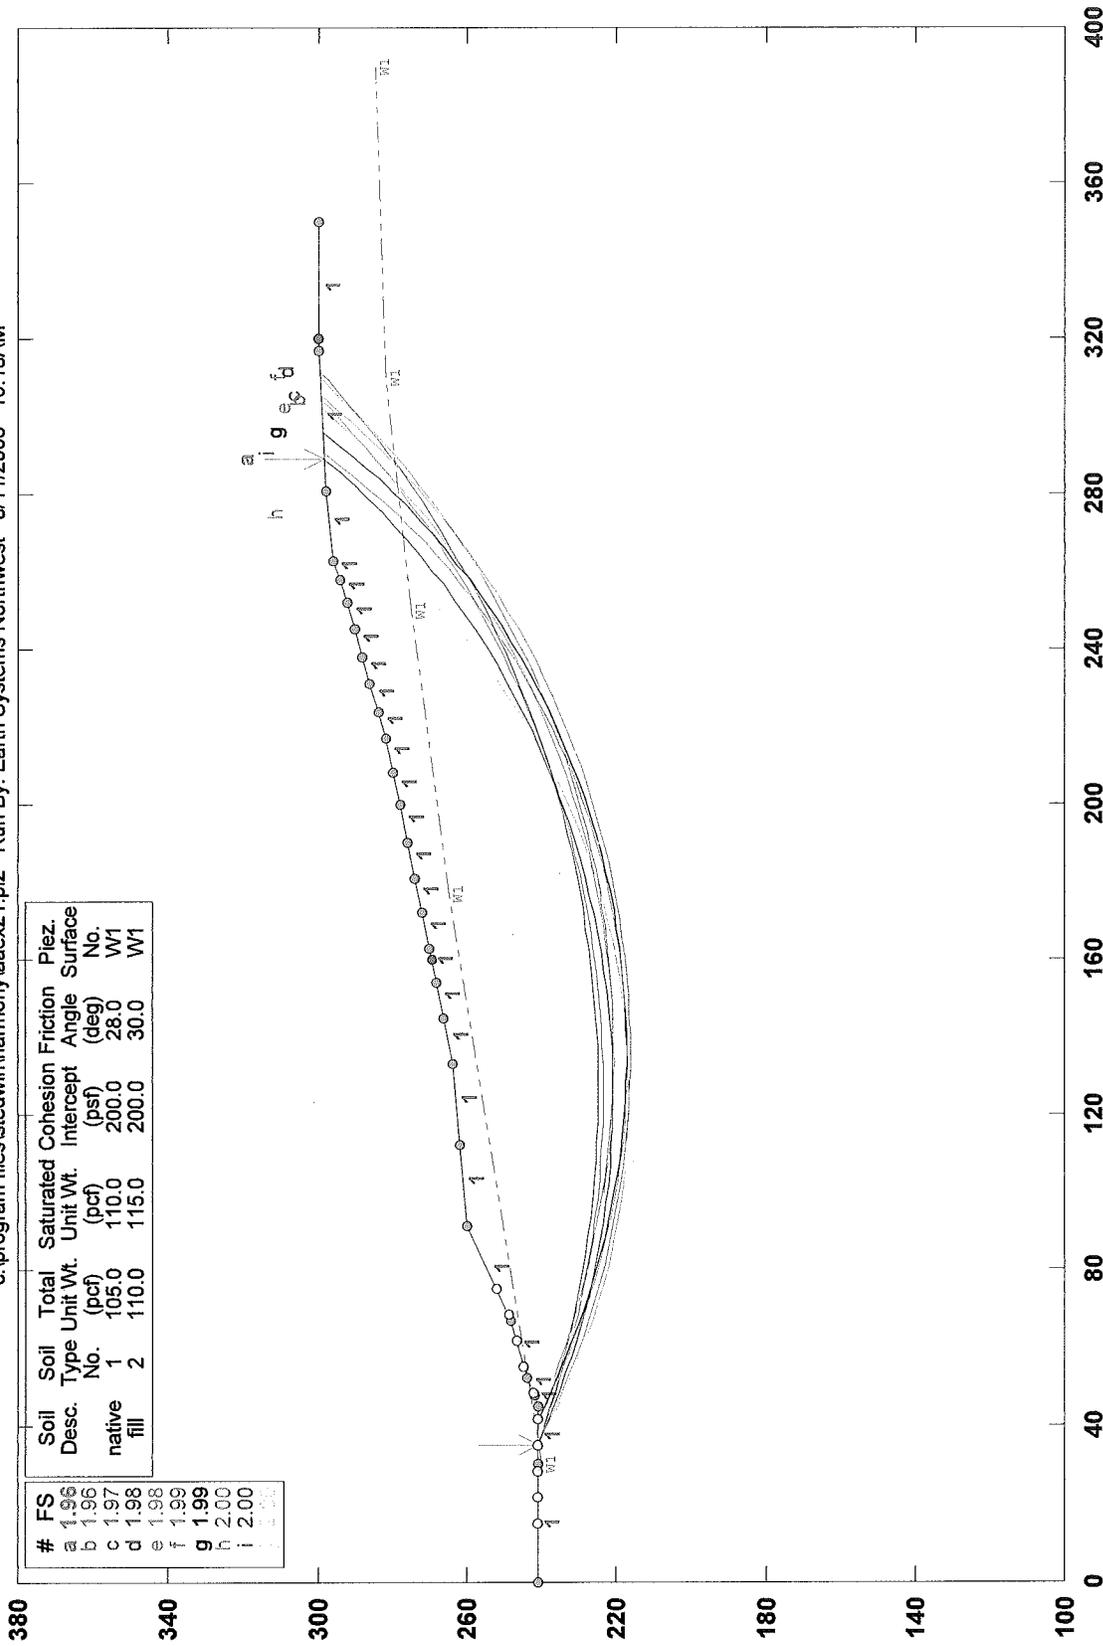
Harmony Heaven - Existing Slope - Pond to Lot 9 - Static-Rotational

Since no slide plane was identified during deep trenching exploration, none was included in the model. It appears that rotational failure would be the likely critical failure mechanism. Based on the result of our analyses, we believe the existing slope appears relatively stable at the current gradient and poses no apparent risk of slope instability.

STABL6H FSmin=1.96
Safety Factors Are Calculated By The Modified Bishop Method

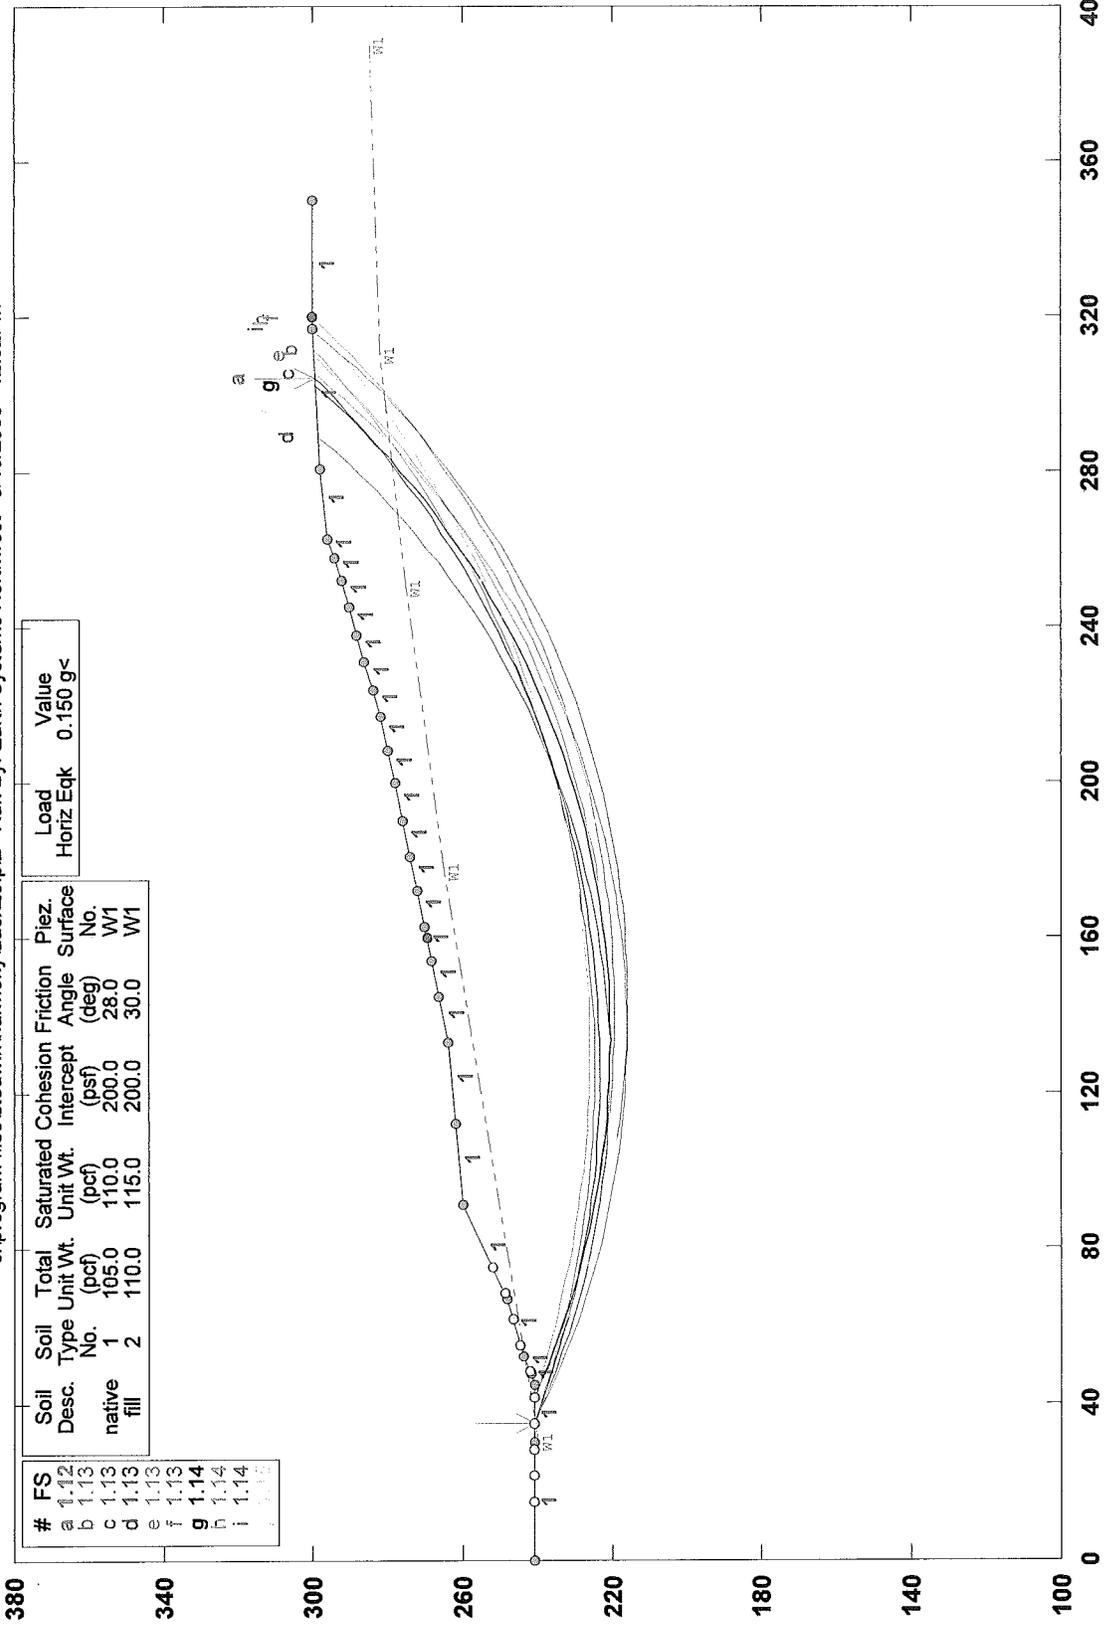
Harmony Heaven - Existing Slope - Pond to Lot 9 - Dynamic-Rotational

STABL6H FSmin=1.12
Safety Factors Are Calculated By The Modified Bishop Method

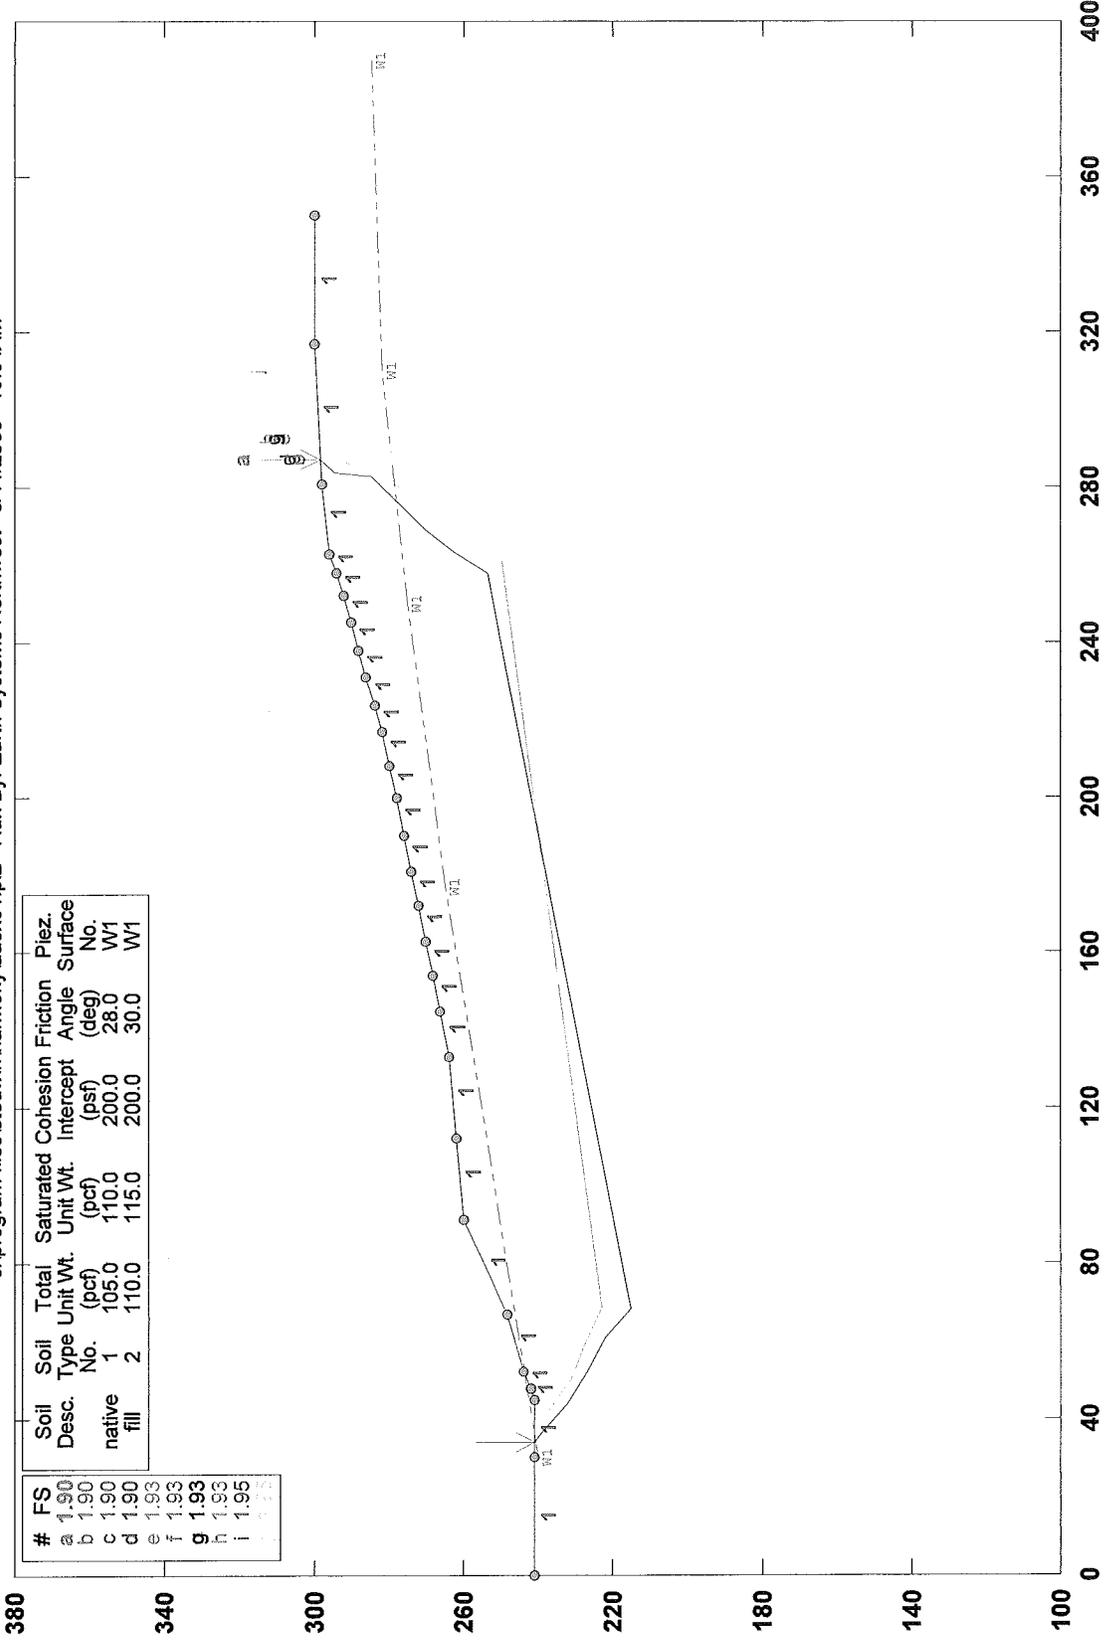
Harmony Heaven - Existing Slope - Pond to Lot 9 - Static-Translational

STABL6H FSmin=1.90
Safety Factors Are Calculated By The Modified Janbu Method

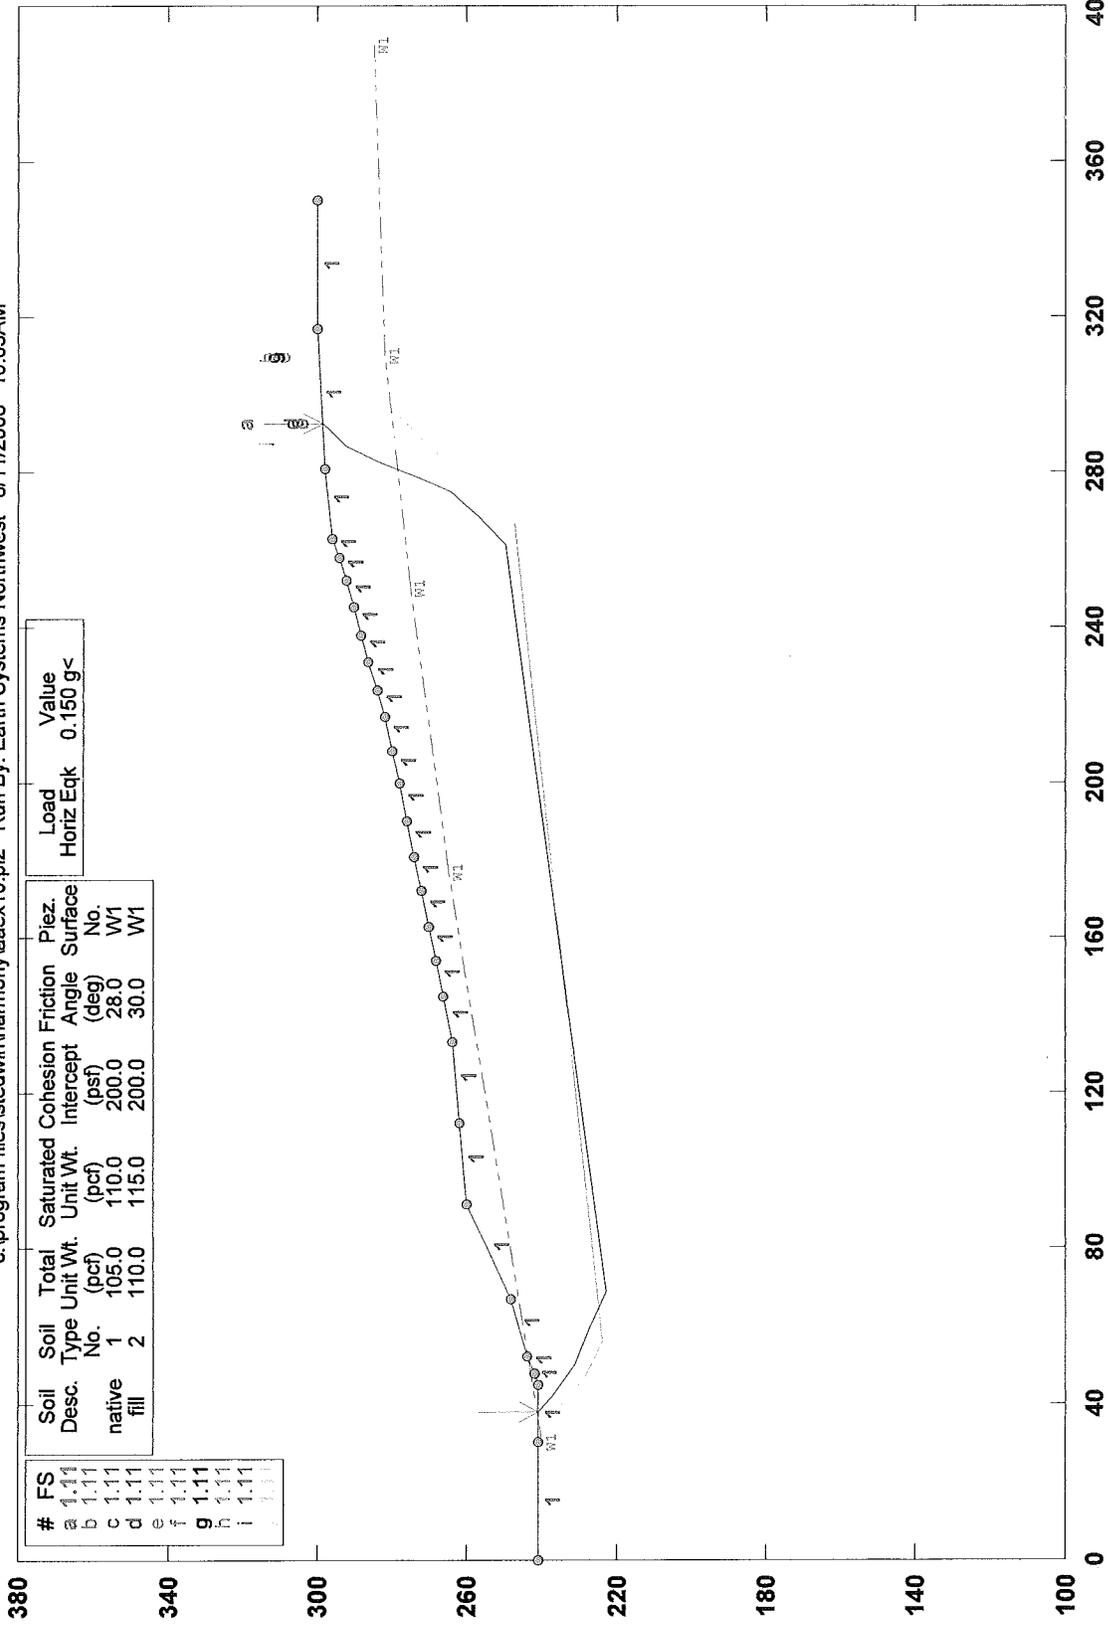
Harmony Heaven - Existing Slope - Pond to Lot 9 - Dynamic-Translational

STABL6H FSmin=1.11

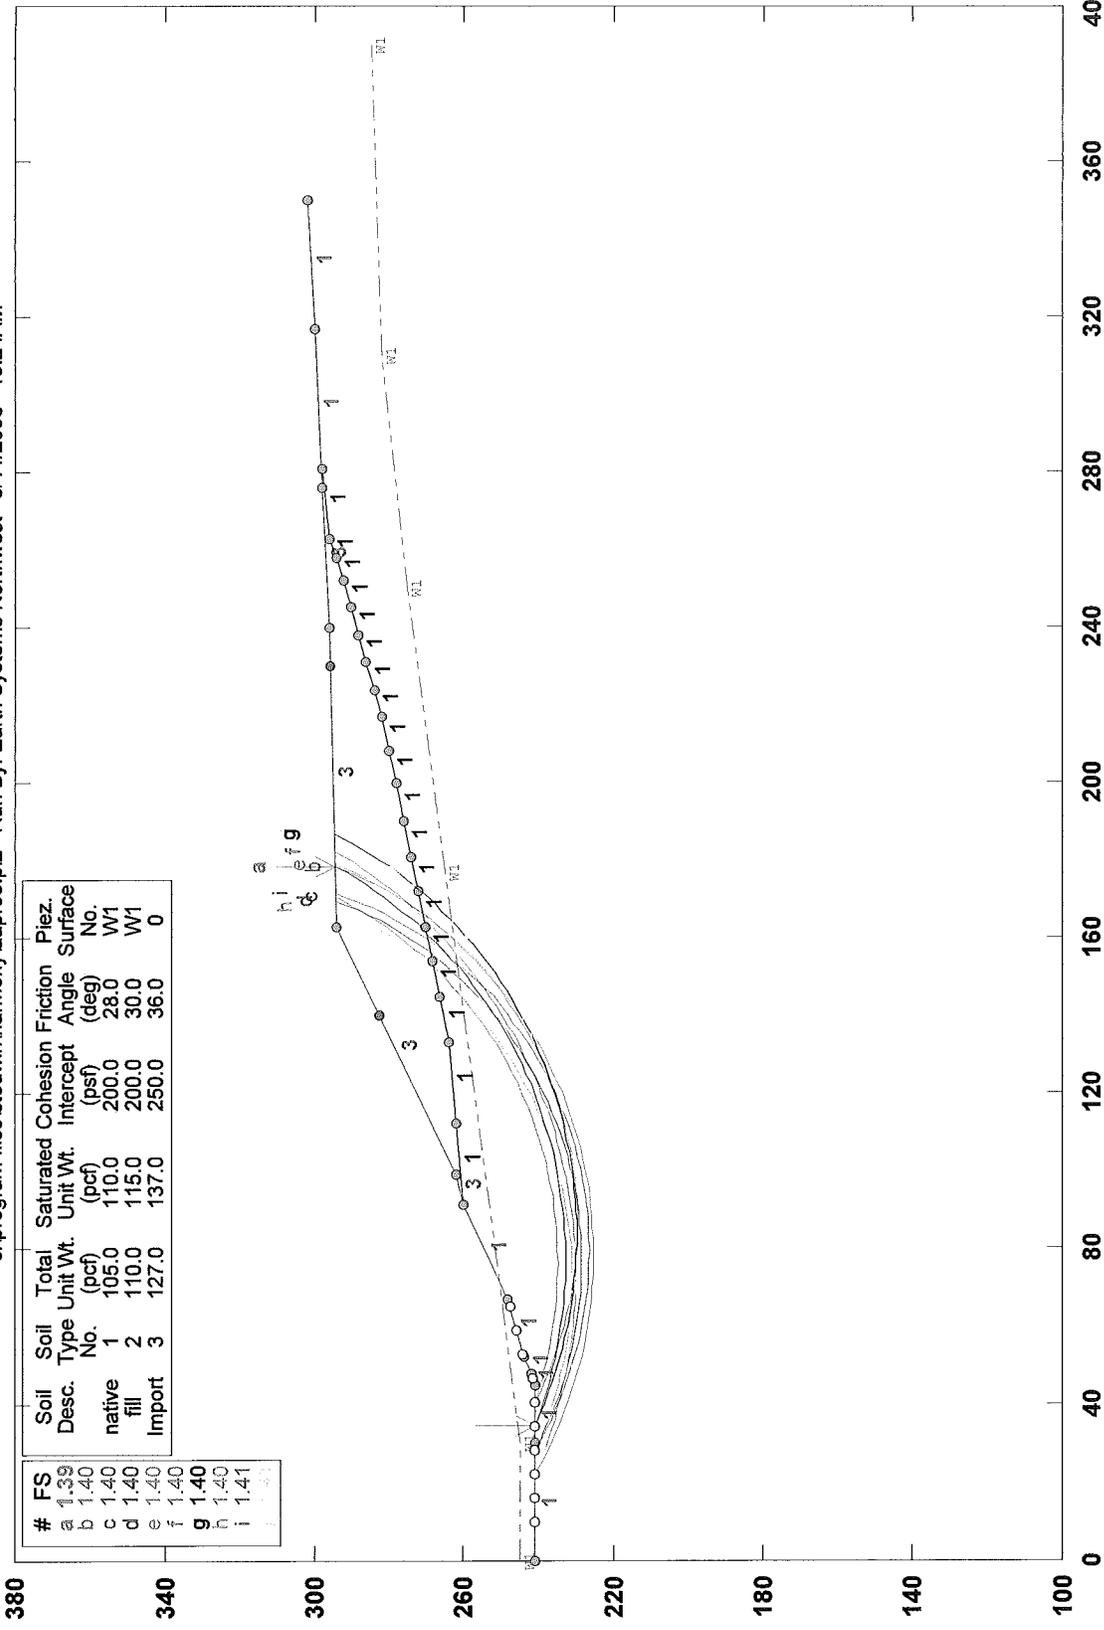
Harmony Heaven - Proposed Slope - Pond to Lot 9 - Static-Rotational

#	FS	Soil Desc.	Soil Type No.	Total Unit Wt. (pcf)	Saturated Unit Wt. (pcf)	Cohesion (psf)	Friction Angle (deg)	Piez. Surface No.
a	1.39	native	1	105.0	110.0	200.0	28.0	W1
b	1.40	fill	2	110.0	115.0	200.0	30.0	W1
c	1.40	Import	3	127.0	137.0	250.0	36.0	0

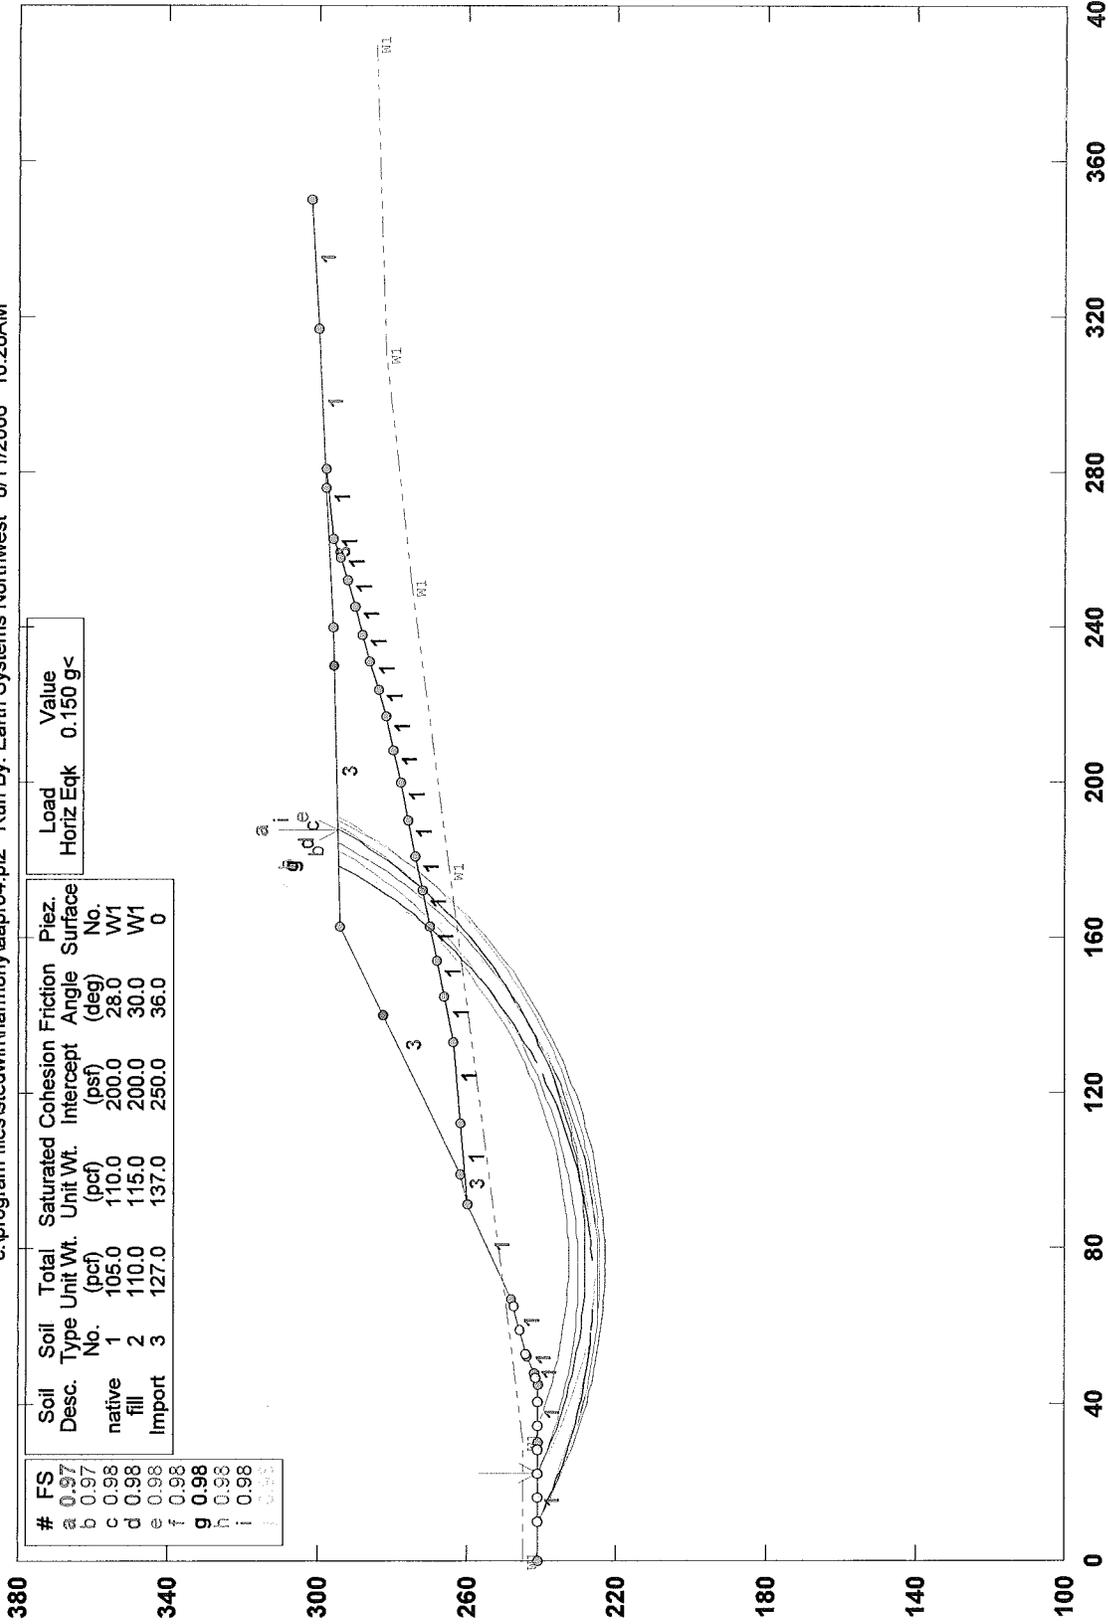
Harmony Heaven - Proposed Slope - Pond to Lot 9 - Dynamic-Rotational

#	FS	Soil Desc.	Soil Type No.	Total Unit Wt. (pcf)	Saturated Unit Wt. (pcf)	Cohesion (psf)	Friction Angle (deg)	Piez. Surface No.
a	0.97	native	1	105.0	110.0	200.0	28.0	W1
b	0.98	fill	2	110.0	115.0	200.0	30.0	W1
c	0.98	Import	3	127.0	137.0	250.0	36.0	0

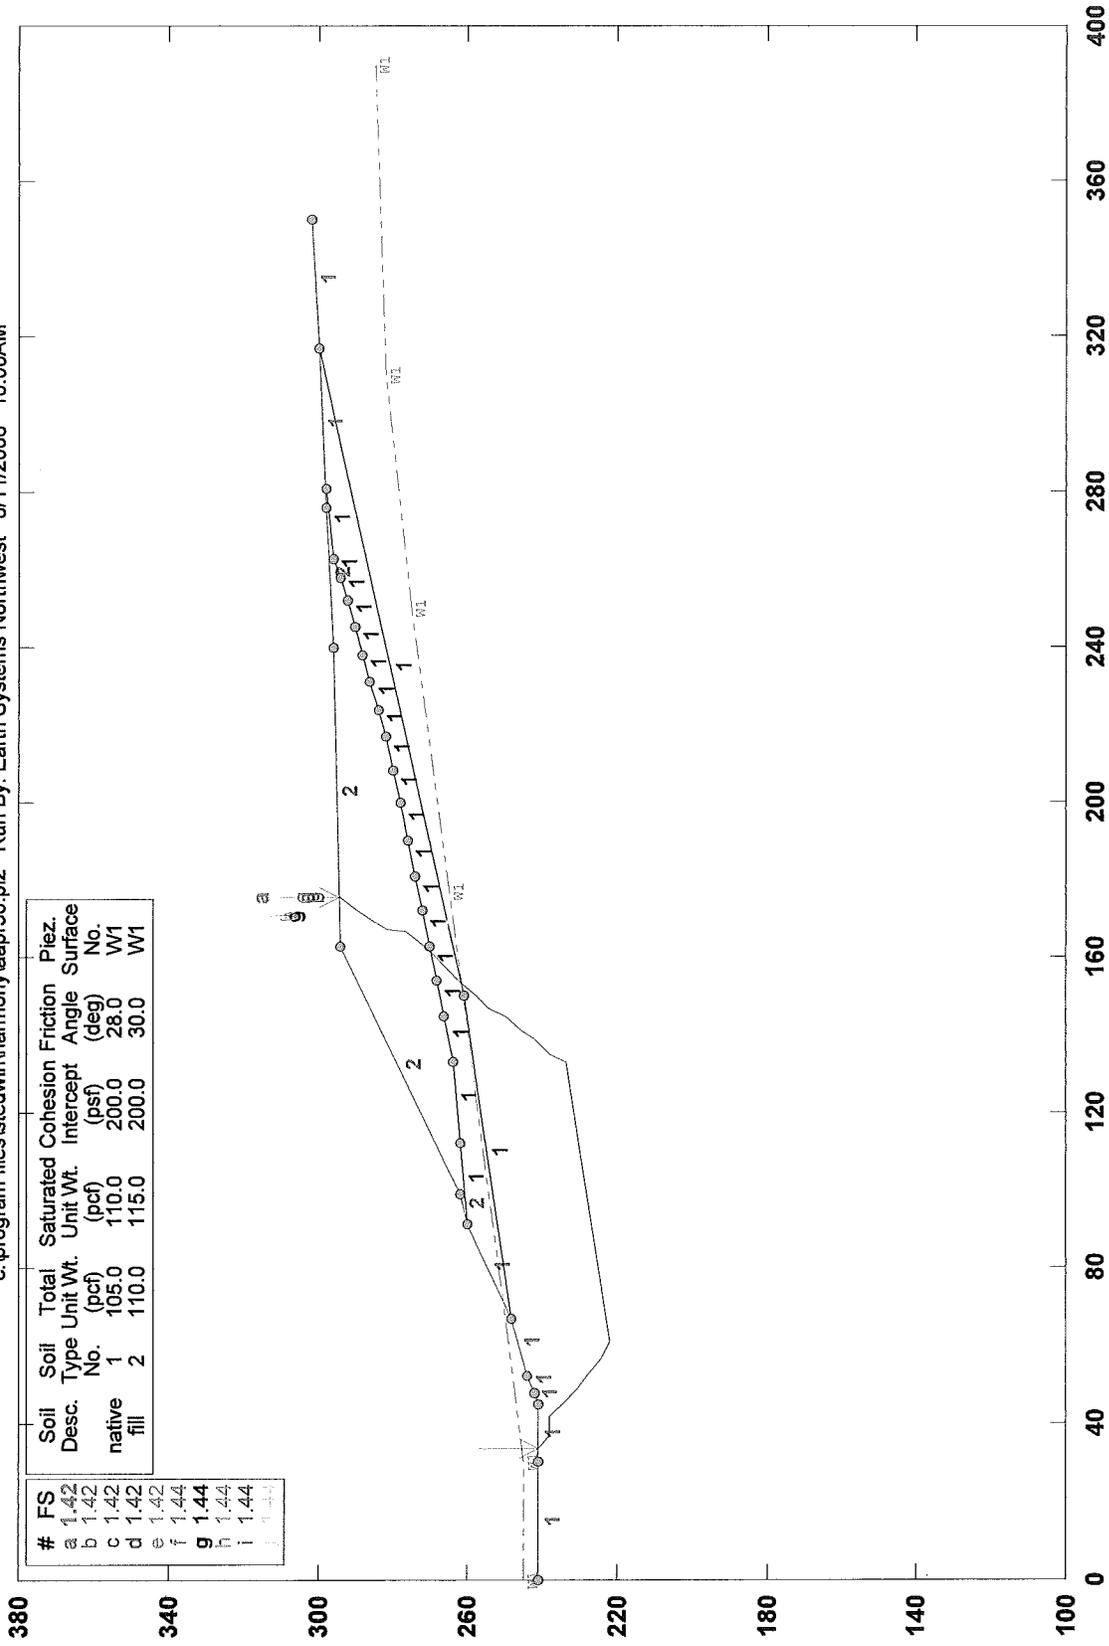
Harmony Heaven - Proposed Slope - Pond to Lot 9 - Static- Translational

#	FS	Soil Desc.	Soil Type No.	Total Unit Wt. (pcf)	Saturated Unit Wt. (pcf)	Cohesion (psf)	Friction Angle (deg)	Piez. Surface No.
a	1.42	native	1	105.0	110.0	200.0	28.0	W1
b	1.42	fill	2	110.0	115.0	200.0	30.0	W1

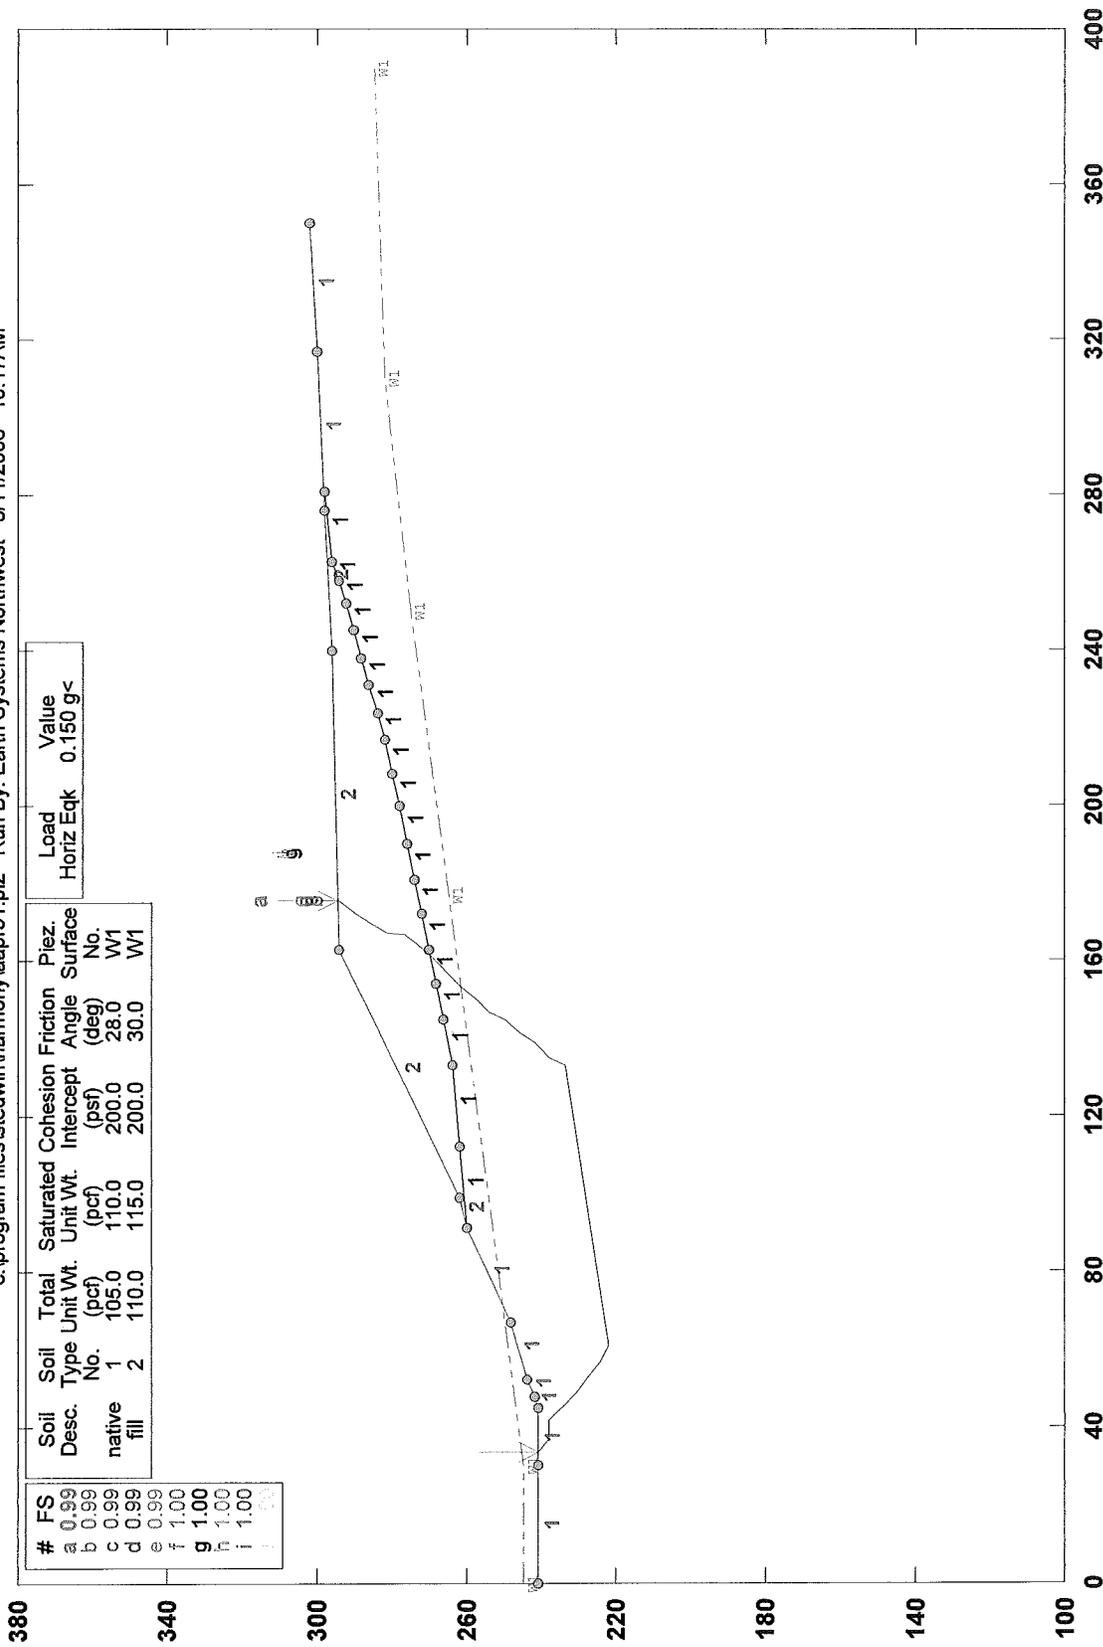
Harmony Heaven - Proposed Slope - Pond to Lot 9 - Dynamic-Translational

#	FS	Soil Desc.	Soil Type No.	Total Unit Wt. (pcf)	Saturated Unit Wt. (pcf)	Cohesion (psf)	Friction Angle (deg)	Piez. Surface No.	Load Horiz Eqk	Value
a	0.99	native	1	105.0	110.0	200.0	28.0	W1	0.150	g<
b	0.99	fill	2	110.0	115.0	200.0	30.0	W1		
c	0.99									
d	0.99									
e	0.99									
f	1.00									
g	1.00									
h	1.00									
i	1.00

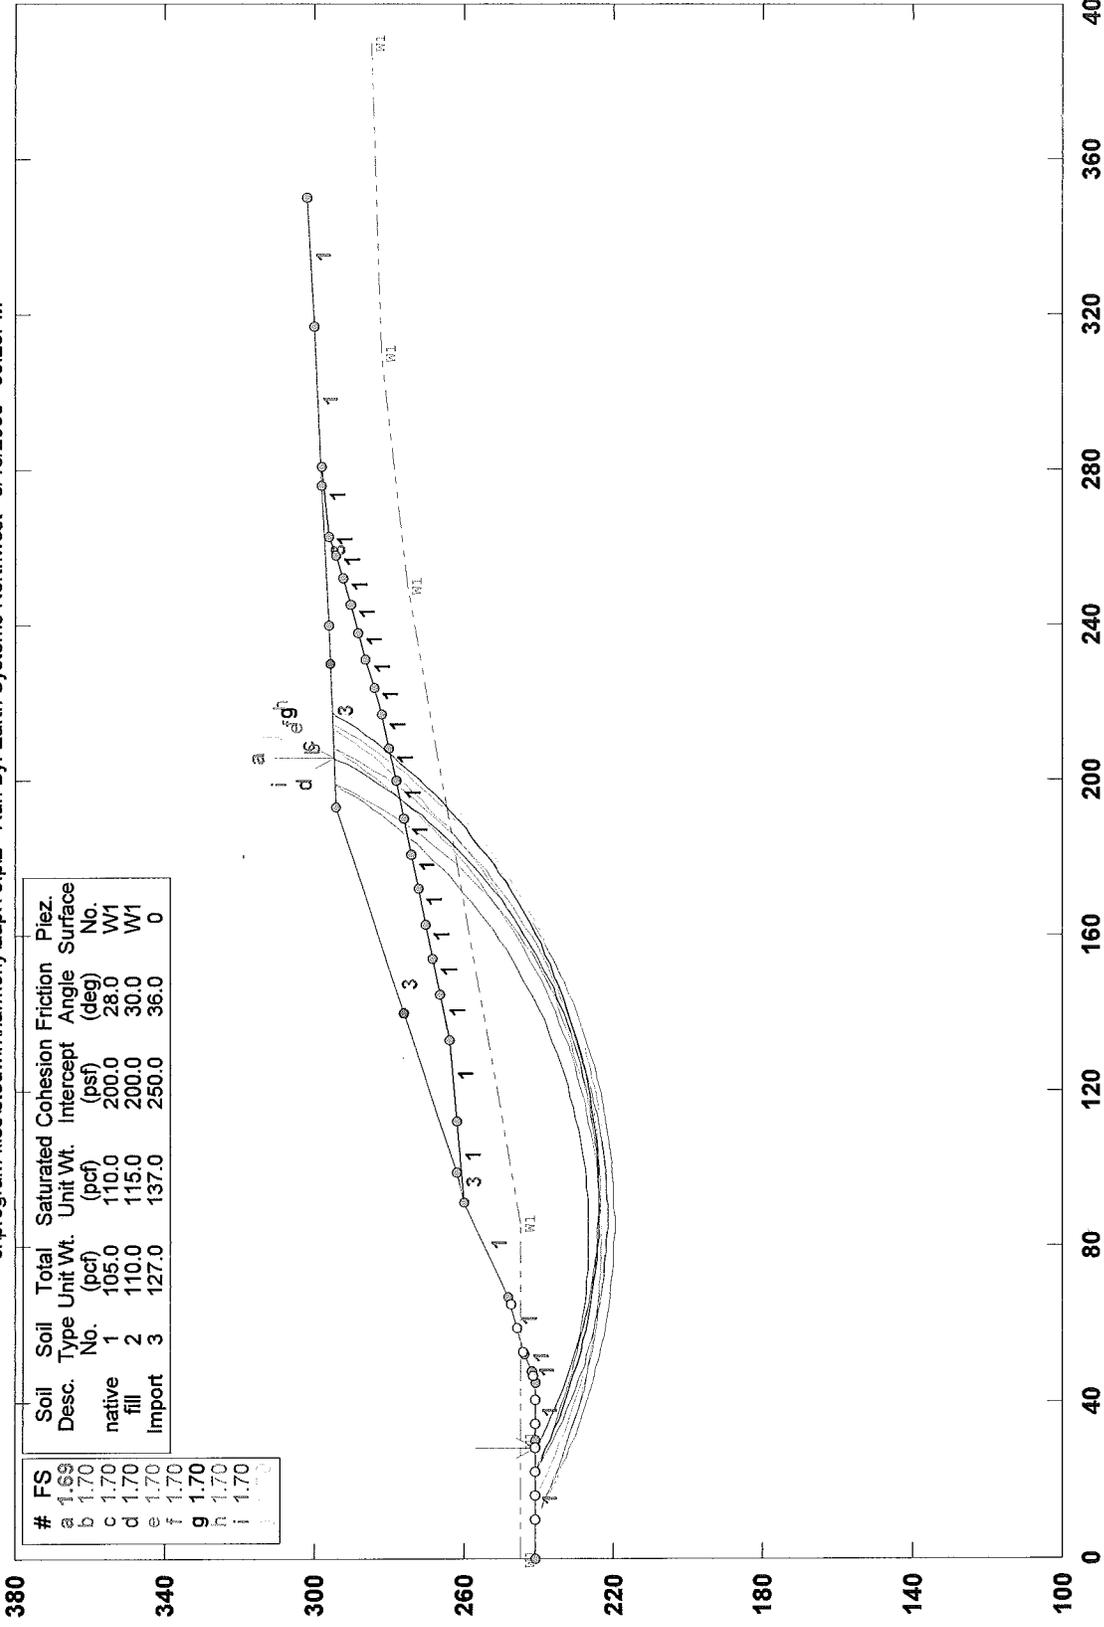
Harmony Heaven - Reconfigured Slope - Pond to Lot 9 - Static-Rotational

The project civil engineer provided us a revised grading plan laying the slope back as we recommended. The slope transitions from a 2:1 at the trail to a 3:1 opposite to the pond. Using this revised slope configuration we ran a slope stability analysis as a 3:1 slope including a shallow groundwater table and conservative design parameters for static and dynamic loading conditions. The results of our analysis indicate stable slope conditions. Static Factor of Safety (FS) is 1.77 and dynamic is 1.12. Results of the analyses are attached to this report.

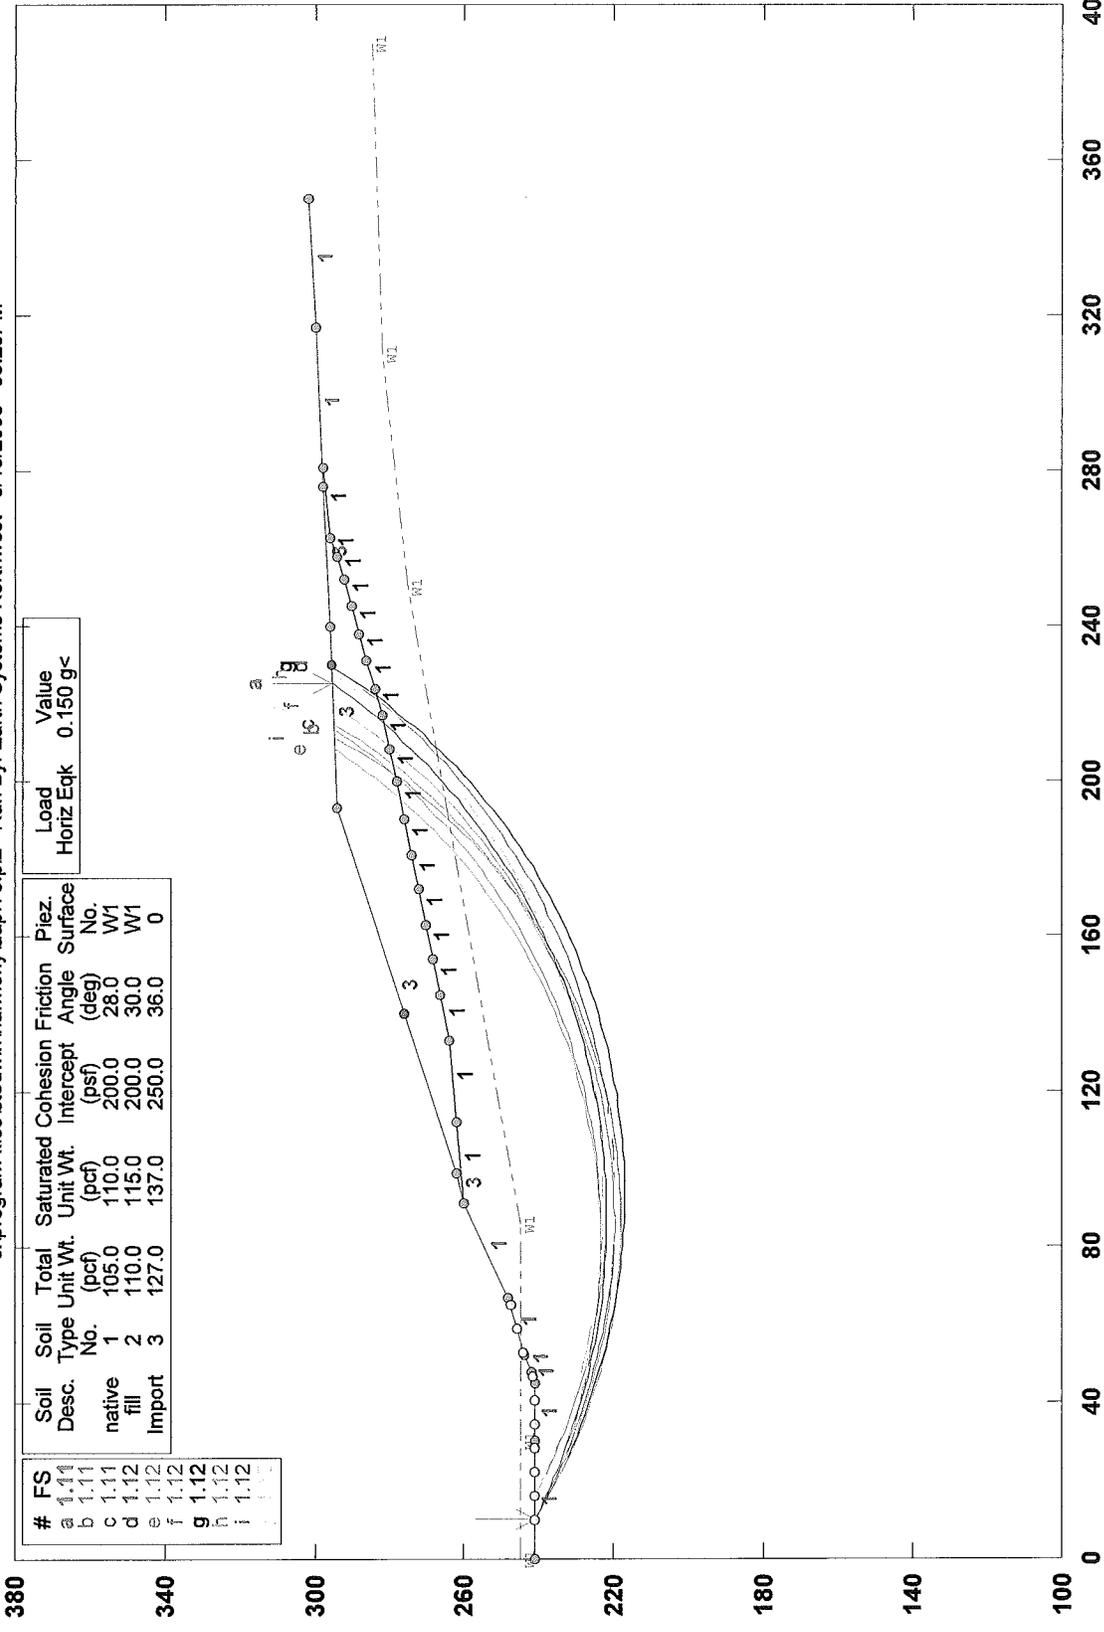
Harmony Heaven - Reconfigured Slope - Pond to Lot 9 - Dynamic-Rotational

#	FS	Soil Desc.	Soil Type No.	Total Unit Wt. (pcf)	Saturated Unit Wt. (pcf)	Cohesion (psf)	Friction Angle (deg)	Piez. Surface No.
a	1.11	native	1	105.0	110.0	200.0	28.0	W1
b	1.11	fill	2	110.0	115.0	200.0	30.0	W1
c	1.11	Import	3	127.0	137.0	250.0	36.0	0
d	1.12							
e	1.12							
f	1.12							
g	1.12							
h	1.12							
i	1.12							
j	1.12							
k	1.12

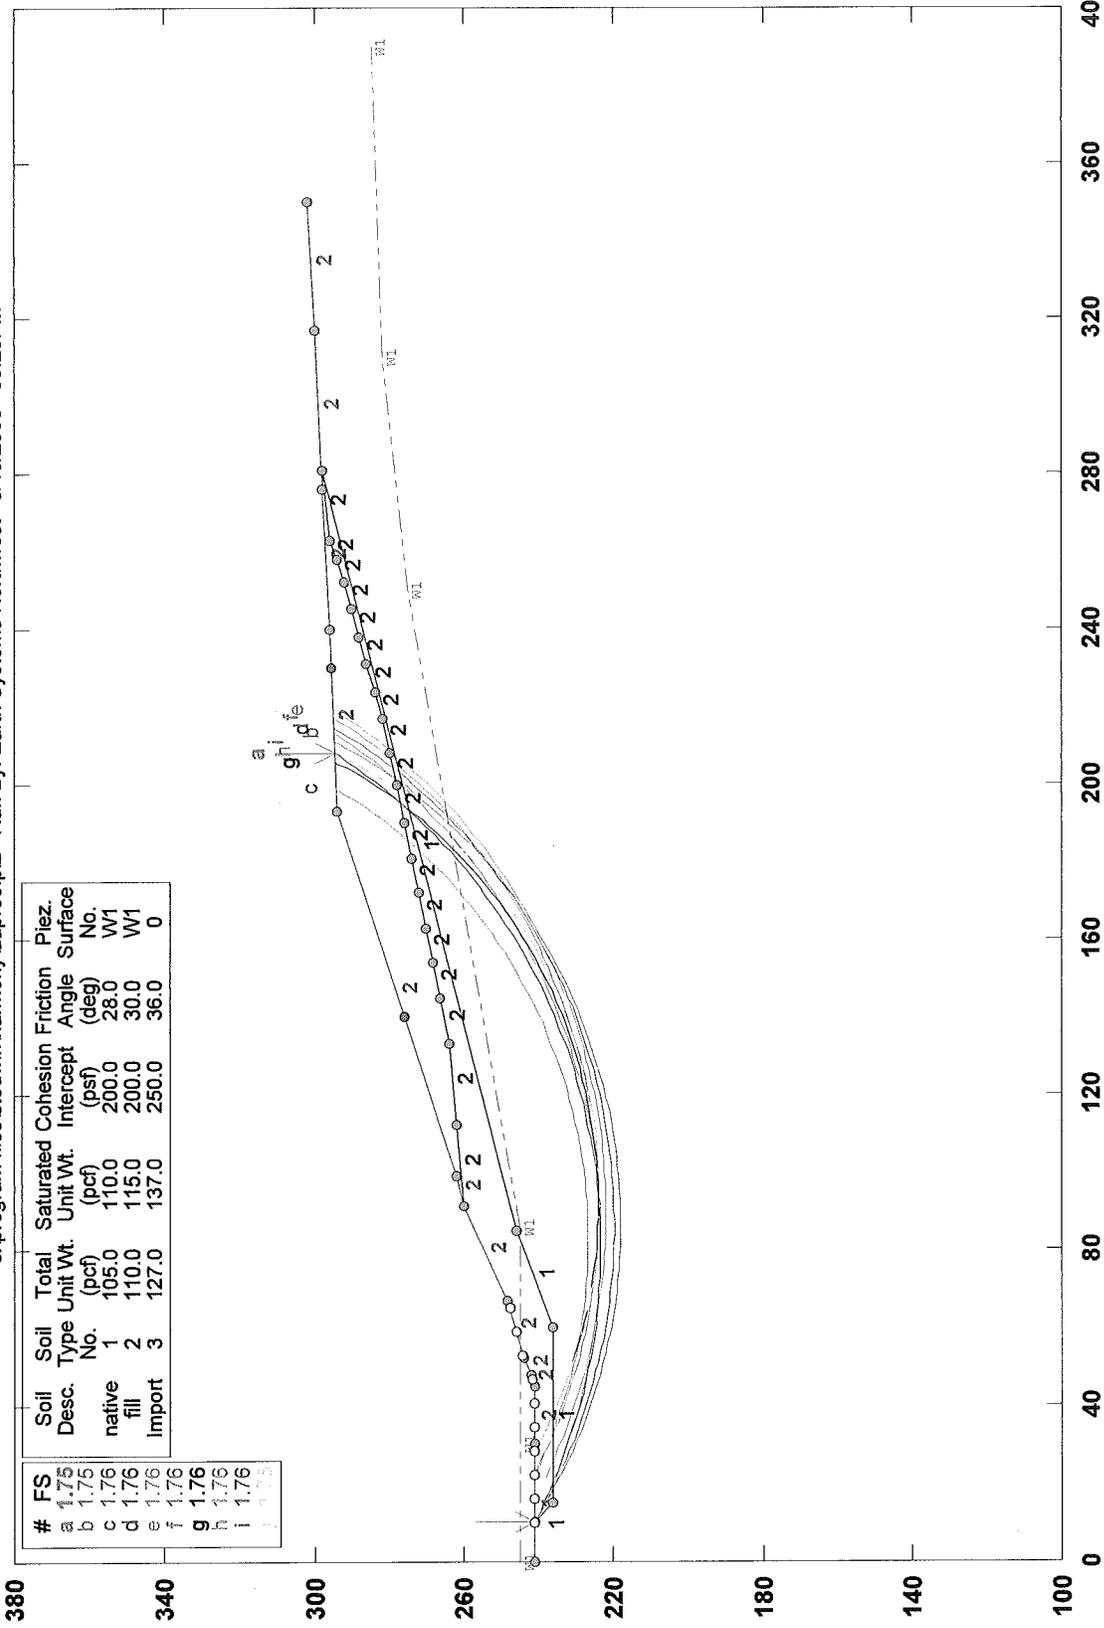
Harmony Heaven - Reconfigured/Buttressed- Pond to Lot 9 - Static-Rotational

STABL6H FSmin=1.75
Safety Factors Are Calculated By The Modified Bishop Method
