August 23, 2006

Re: Harmony Heaven- A Planned Unit Development, Cascade Locks, Oregon
GNN Job #: 206-623-1

Subject: Supplemental Geotechnical Engineering Report

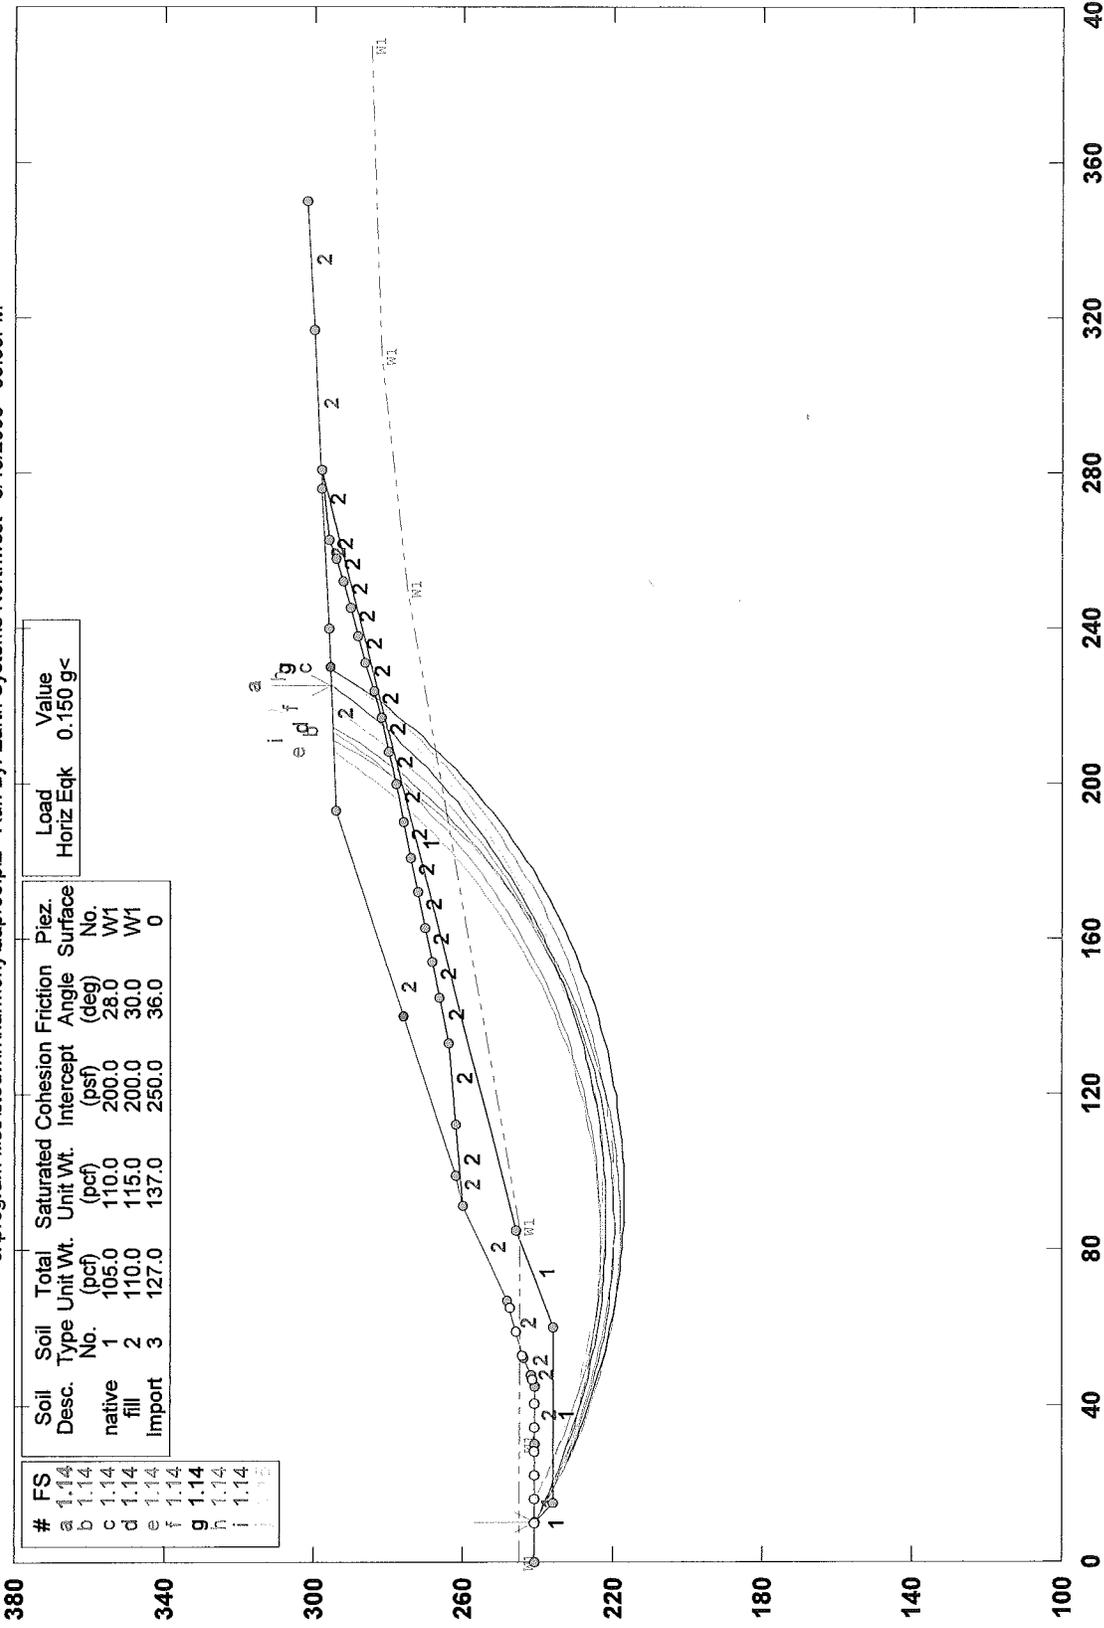
Harmony Heaven - Reconfigured/Buttress - Pond to Lot 9 - Dynamic-Rotational

#	FS	Soil Desc.	Type No.	Total Unit Wt. (pcf)	Saturated Unit Wt. (pcf)	Cohesion (psf)	Friction Angle (deg)	Piez. Surface No.	Load Horiz Eqk	Value
a	1.14	native	1	105.0	110.0	200.0	28.0	W1		
b	1.14	fill	2	110.0	115.0	200.0	30.0	W1		
c	1.14	Import	3	127.0	137.0	250.0	36.0	0		0.150 g<

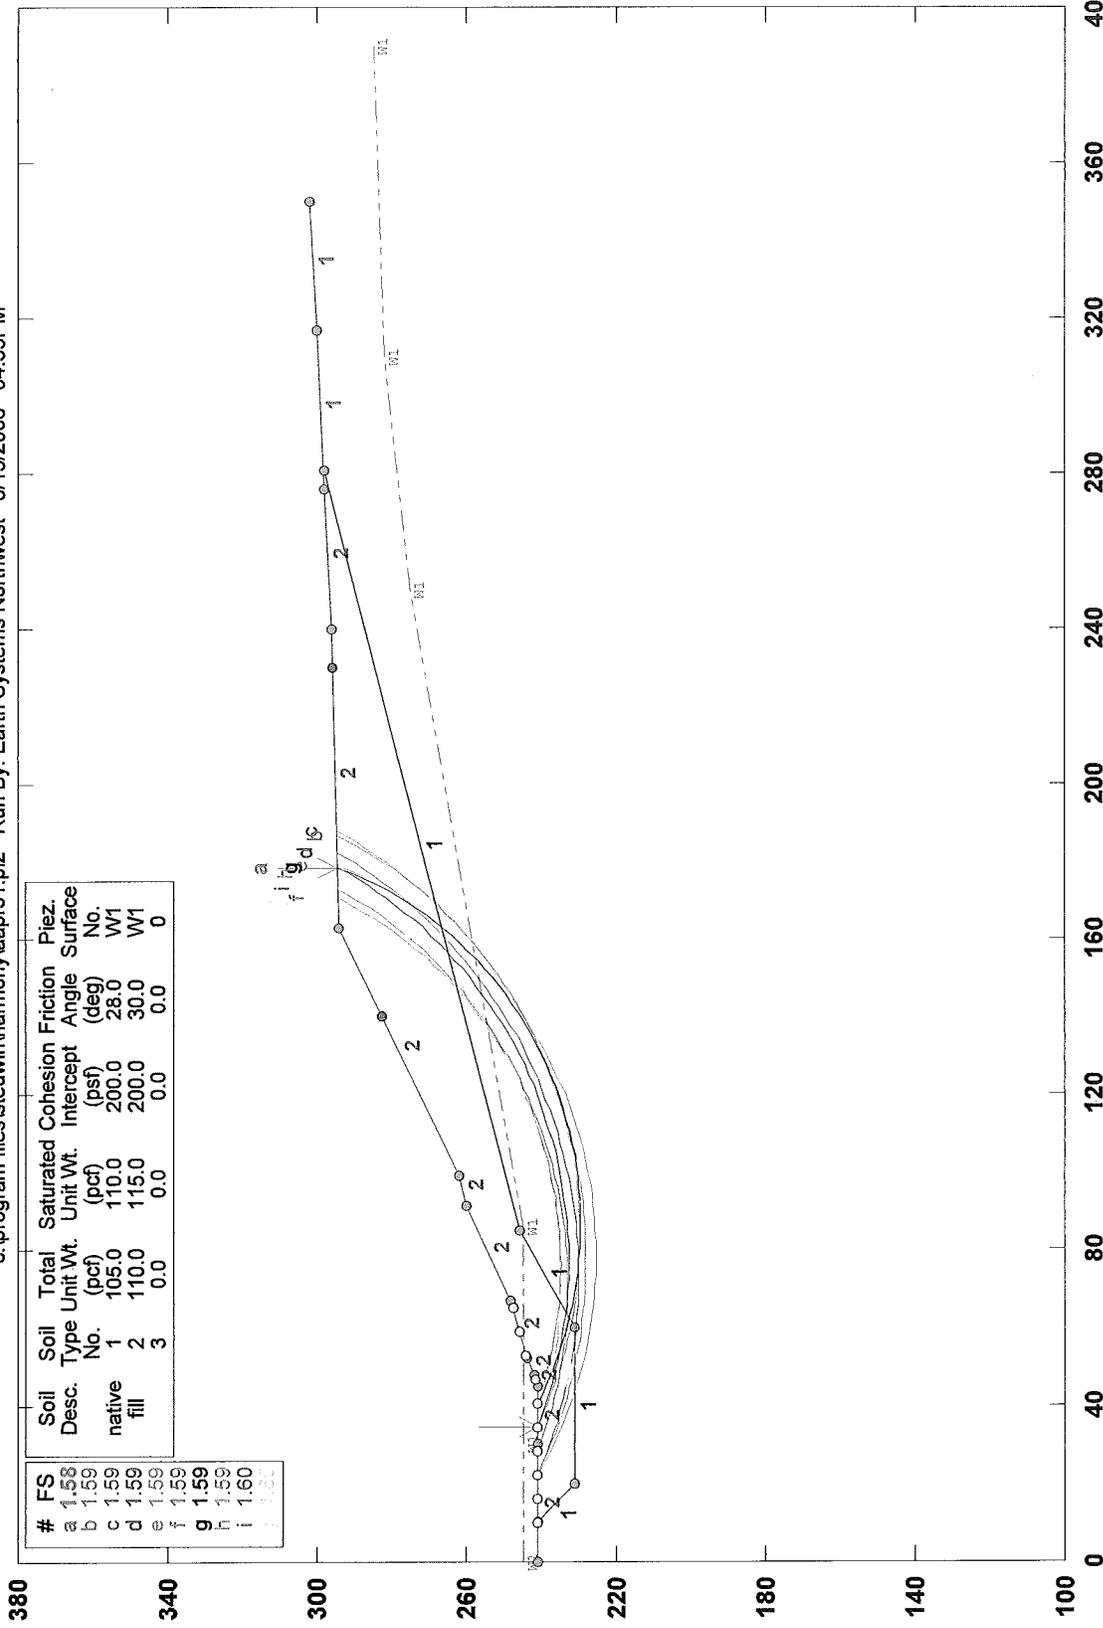
Harmony Heaven - Buttressed Slope A - Pond to Lot 9 - Static-Rotational

STABL6H FSmin=1.58
Safety Factors Are Calculated By The Modified Bishop Method

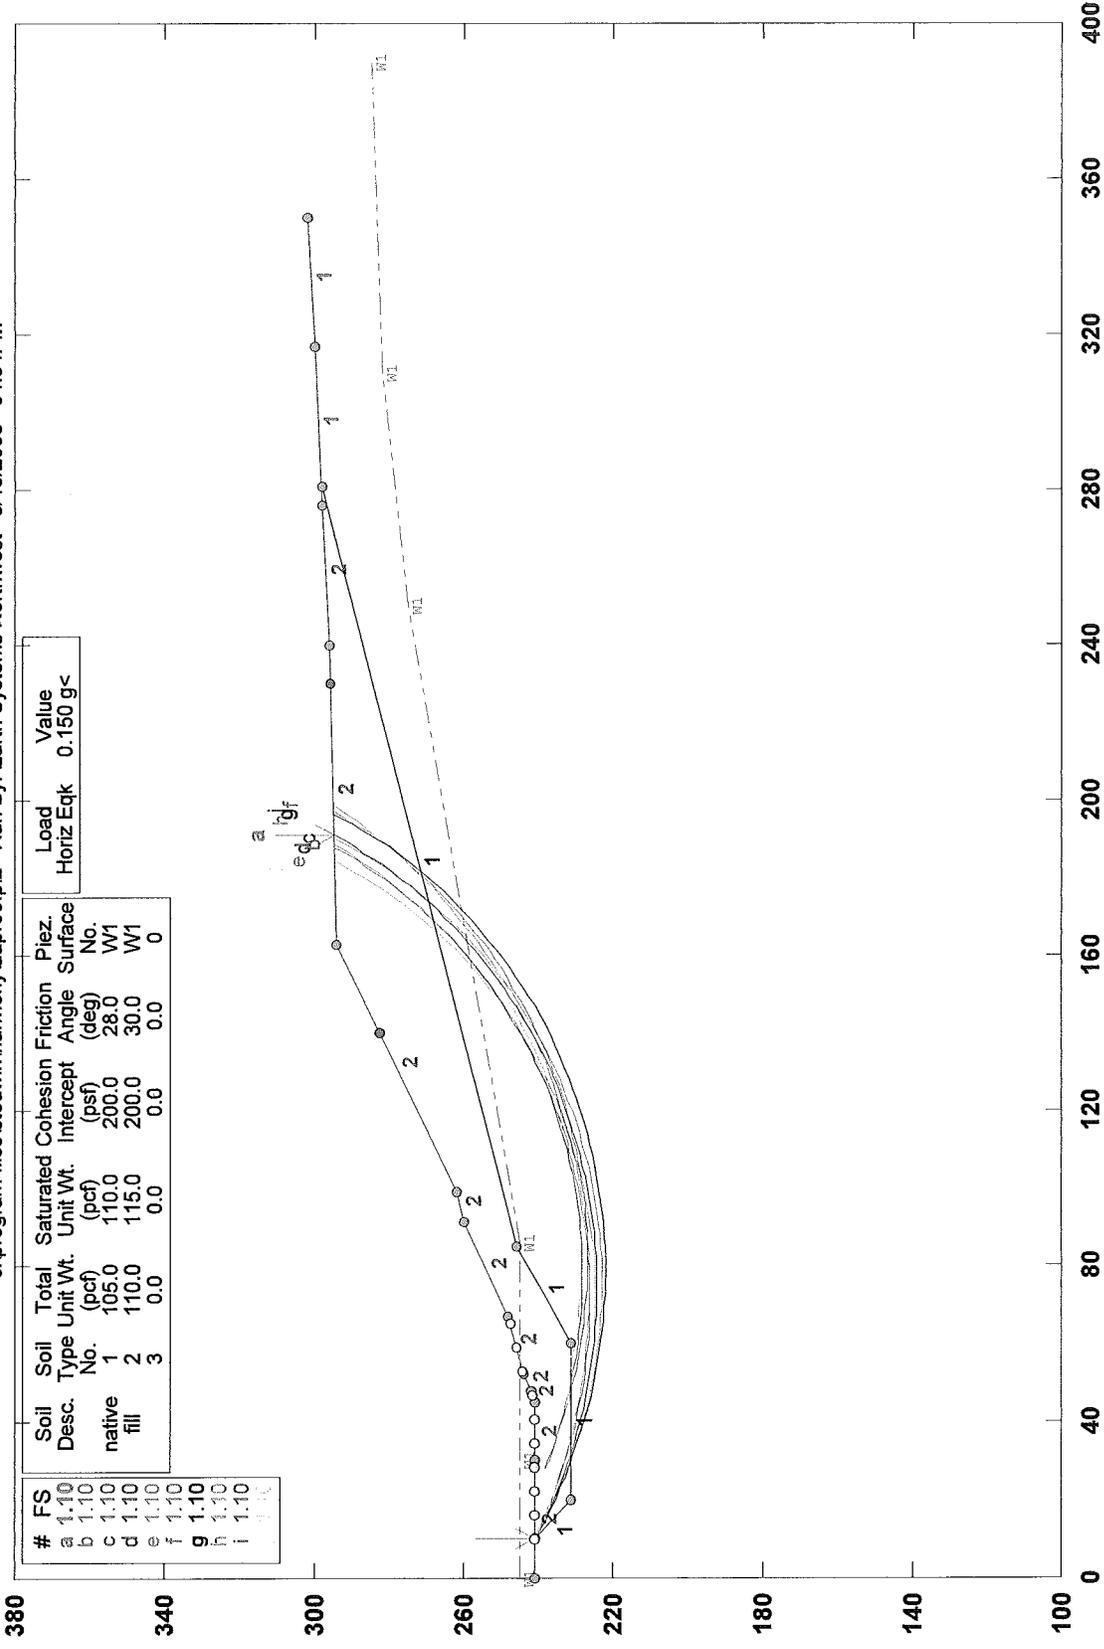
Harmony Heaven - Buttressed Slope A - Pond to Lot 9 - Dynamic-Rotational

#	FS	Soil Desc.	Soil Type No.	Total Unit Wt. (pcf)	Saturated Unit Wt. (pcf)	Intercept (psf)	Friction Angle (deg)	Piez. Surface No.
a	1.10	native	1	105.0	110.0	200.0	28.0	W1
b	1.10	fill	2	110.0	115.0	200.0	30.0	W1
c	1.10	fill	3	0.0	0.0	0.0	0.0	0
d	1.10							
e	1.10							
f	1.10							
g	1.10							
h	1.10							
i	1.10
